HOFFMAN CONSTRUCTION COMPANY

UTILITY LEVEL MOD1

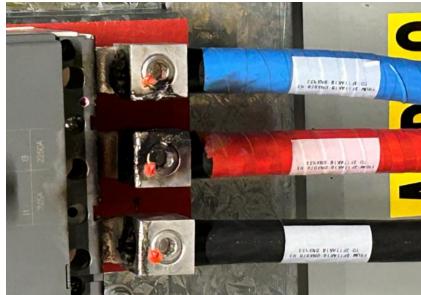
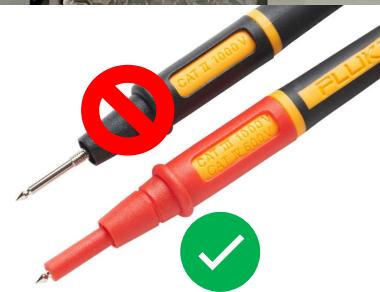
DATE/TIME OF INCIDENT: 12/12/2024 09:10 AM LOCATION UTILITY 52.1 AK-18

An arc flash occurred while an employee was concluding a voltage check on a recently energized panel. When transitioning from B-N to C-N, the tip of the meter lead contacted both B & C phases, resulting in the arc flash.

Personnel / Human Error

The use of protective rubber boots for fluke voltage meter leads will be implemented.

- · Protective rubber boots will be installed on all contractor's fluke voltage meter leads.
- · Update contractor's site wide policy for fluke voltage use to incorporate the protective rubber boots.
- · Electrical contractor to conduct a stand down for crews to review incident and updated corrective actions.
